# Property Inspection Report

Report Reference — SP-2601-0142

**[Property Address]**

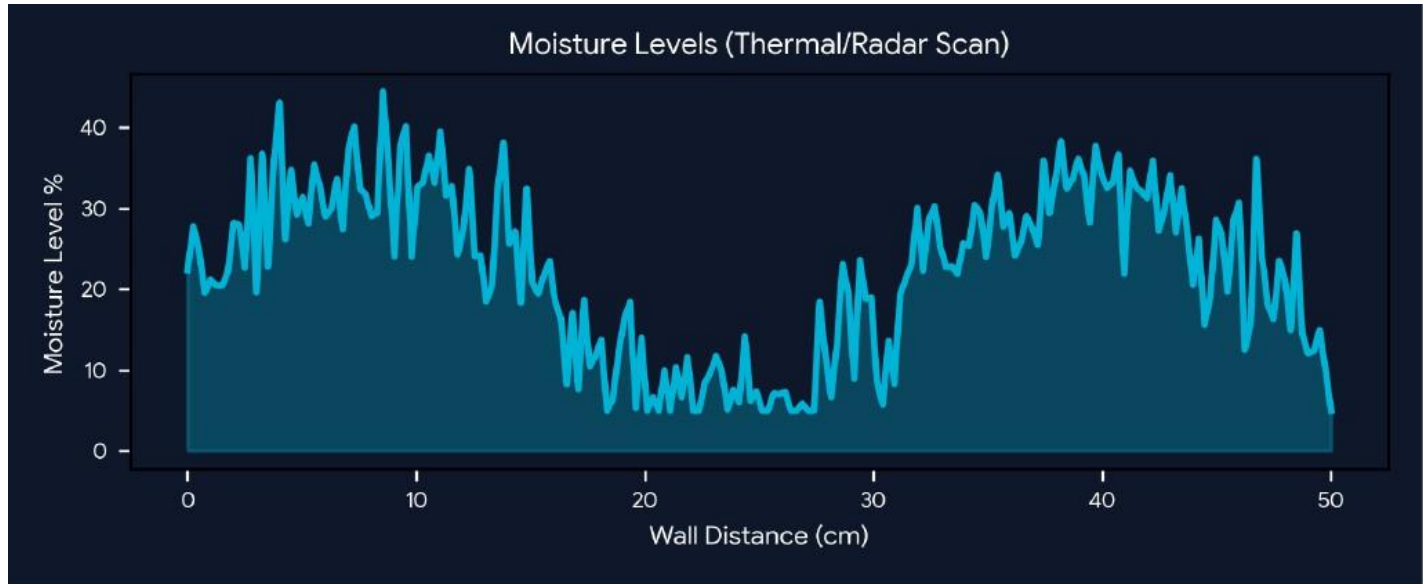
**MAJOR ISSUE Location: Guest Bedroom 2 (GBR-2) Bathroom Corner**

**Observation:** Seepage detected at wall corner adjacent to shower tap assembly.

**Probable Cause:** Concealed plumbing connector leakage behind shower wall flange.

**Recommended Rectification:** Dismantle tap fitting, replace damaged washer/gasket, apply Teflon tape, and seal pipe Wall penetration.
